Process Sheet

Customer	: CC-DAR01 Dart Aerospace Ltd.	Drawing Name	: REWORK
Job Number	: 39664		
Estimate Number	: 10804		
P.O. Number	:	Part Number	: D3276042
This Issue	: 03/06/2008 S.O. No. :	Drawing Number	: NCR08-053
Prsht Rev.	: NC	Project Number	:
First Issue	: / / Type : SMALL /MED FAB	Drawing Revision	:
Previous Run	: 39663	Material	:
Written By	:

D3276-041 BAFFLE ASSEMBLY, LH (SHOWN) D3276-042 BAFFLE ASSEMBLY, RH (BEND/JOGGLE OPPOSITE)

From: David Shepherd [dshepherd@dartaero.com]
Sent: June 26, 2008 1:08 PM
To: 'Chris Provencal'
Cc: 'Mike Petsche'
Subject: RE: NCR D3276-041

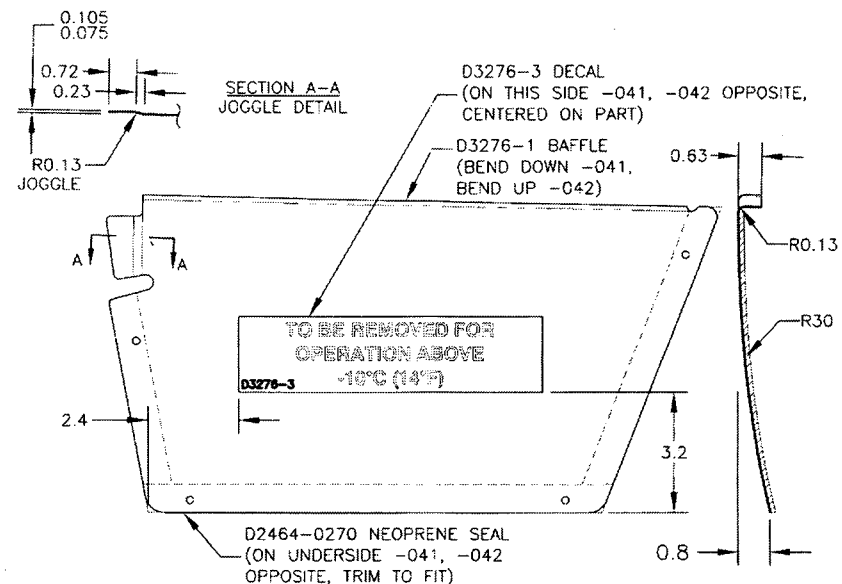
I would be inclined to accept these parts. As you mention, they will not be under any load. Also, if the tab breaks off, I have checked with Harvey, and it will fall into an area of the R44 helicopter where it will not cause any damage.

Qty(22) D3276-041 Baffle Assembly. The joggled tab was bent in the opposite direction from the dwg. They were all reworked to the correct the joggle (re-bent opposite). The grain directions are all at 45 degrees (not vertical per dwg). They were bent while powder coated, so it's impossible to inspect the surface of the aluminum in their current state. One baffle cracked during re-bending.

The part is bolted in, the tab is unlikely to be under any significant stress. However, I'm thinking they should maybe strip the parts (at least locally) to inspect the surface for cracks, especially since one cracked during re-bending. That probably won't be popular....

Since they were re-bent after powder, could you do an LPI to check for cracks rather than a powder removal. If the metal is cracked, the paint will also be cracked, right? If not, perhaps you could spot check a couple for cracks?

Do we need to clarify the drawing to prevent this from happening again and to change to the 45 degrees for the future? I believe the 45 degrees was covered on a deviation.
